LIMITED GEOTECHNICAL EVALUATION

COUNTY VISTA DRIVE COMMERCIAL BUILDING
21801 COUNTY VISTA DRIVE
LIBERTY LAKE, WASHINGTON

ALLWEST PROJECT NO. 216-266G

AUGUST 31, 2016

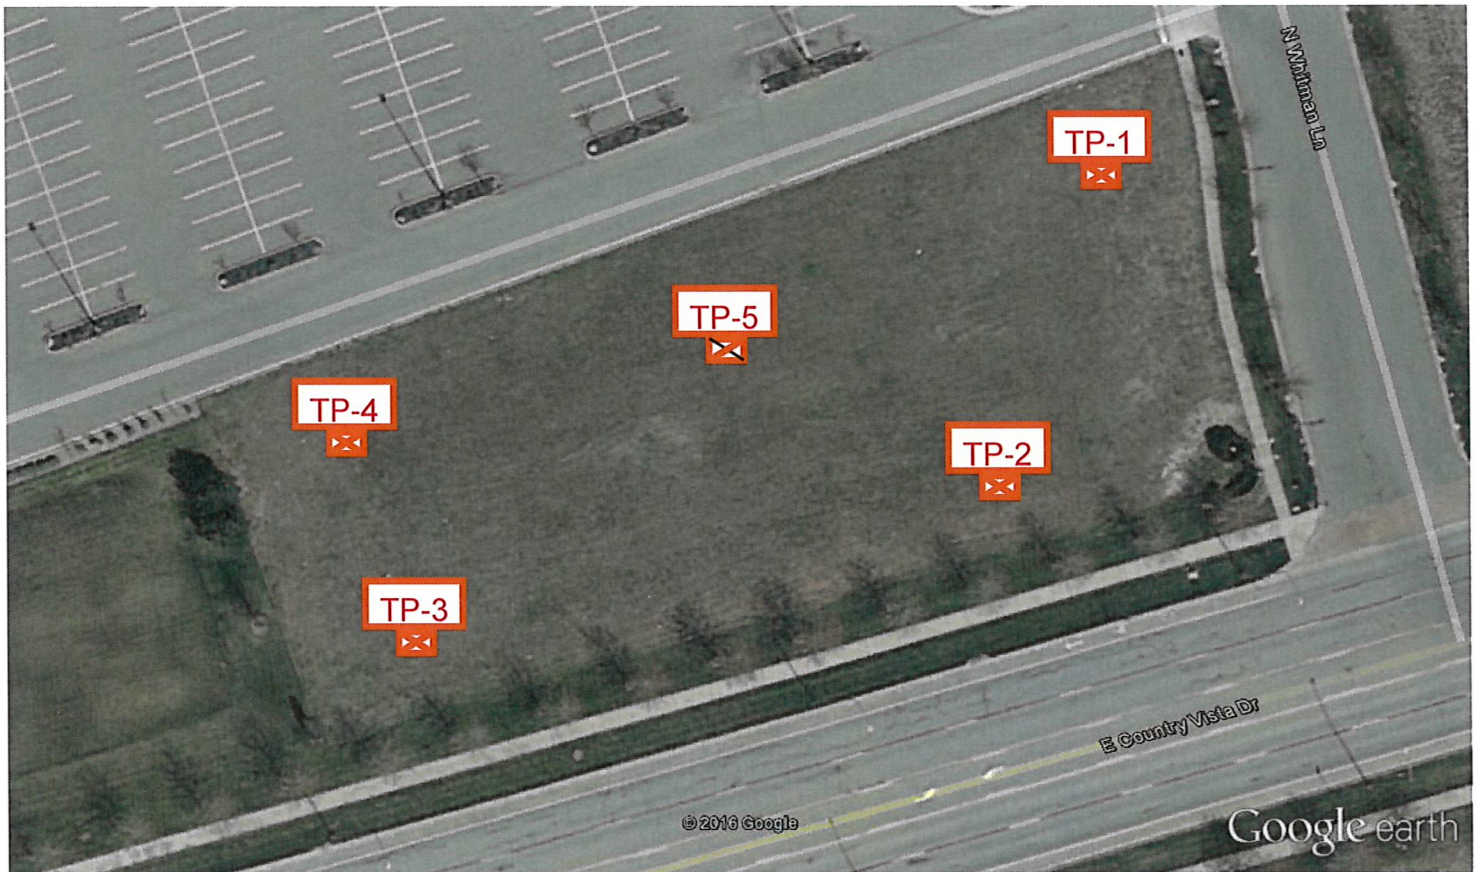
TP-X = Test Pit Number and Location

Five (5) test pits were observed at the site at the approximate locations shown on the Test Pit Location Map, Figure A-3, in Appendix A of this report. The test pit locations were measured from features shown on the site plan provided. The test pits were excavated with a rubber tire backhoe under subcontract to ALLWEST. The soil conditions observed in the test pits were visually described and classified in general accordance with ASTM D 2487 and D 2488 and the subsurface profiles were logged. Representative soil samples were obtained from the test pits.
